**TRANSPORTATION SCIENCES CENTER
ACCIDENT RESEARCH GROUP**

CALSPAN ON-SITE AIR BAG/CHILD PASSENGER FATALITY INVESTIGATION
CALSPAN CASE NO. - ~~CA 94-43~~ CA 96 08
VEHICLE - 1995 HYUNDAI ACCENT
LOCATION - FLORIDA
CRASH DATE - ~~██████~~ 1996

16. <i>Abstract</i> <p>This on-site air bag deployment crash focused on the injury mechanisms for the fatal injuries sustained by a 3 month male passenger who was restrained in a rearward-facing Evenflo On-My-Way child restraint in the right front position of a 1995 Hyundai Accent. The driver of the vehicle was assisting the mother of the infant by following her to a auto repair service center for repairs to the mother's vehicle. Due to a leaky exhaust system, the infant's mother allowed the Hyundai driver to transport the infant in her vehicle and not expose the child to the potentially hazardous exhaust fumes. A third party assisted in the placement of the infant restraint in the right front position of the Hyundai. None of the adults were aware of the risks associated with the risks of rearward-facing child restraints and the deployment of passenger side air bag systems.</p> <p>En route to the service center, the driver of the Hyundai initi

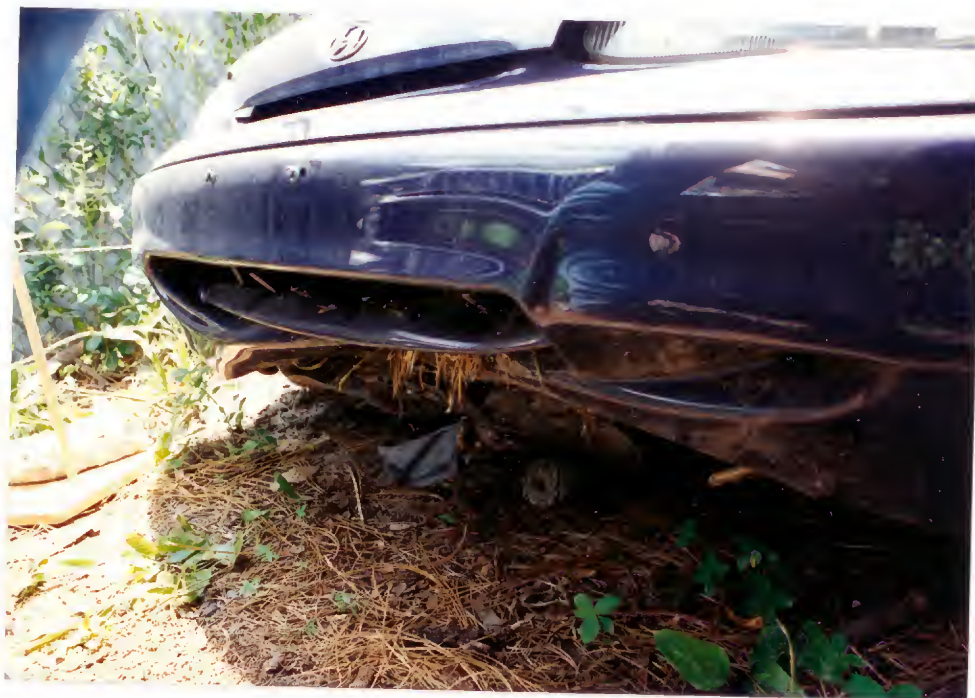
As the Hyundai mounted the barrier curb and traversed the grassy area and concrete sidewalk, the vehicle traveled down the earth embankment in a CW yaw and gouged the embankment with the front undercarriage area. The undercarriage contact (Event No. 3) involved the engine shield that was mounted between the lower bumper fascia and the front crossmember, and the integral valance/air dam of the front bumper fascia. Direct contact damage consisted of abrasions with embedded dirt and vegetation. The damage began 61.0 cm (24.0") left of center and extended 114.3 cm (45.0") across the frontal width of the vehicle. The sheetmetal engine shield was displaced approximately 8.9 cm (3.5") in both an upward and rearward direction. The valance area of the bumper fascia was displaced vertically by the engine shield deformation, however, there was no structural involvement of the bumper assembly. A tie-down bracket was affixed to the leading edge of the undercarriage at the mid point of the vehicle. As a result of the undercarriage contact, the tie-down bracket was deformed in an upward direction and was partially separated from the undercarriage mounting point. This damage is documented in Photograph No.14.

14. Frontal undercarriage damage from embankment contact.

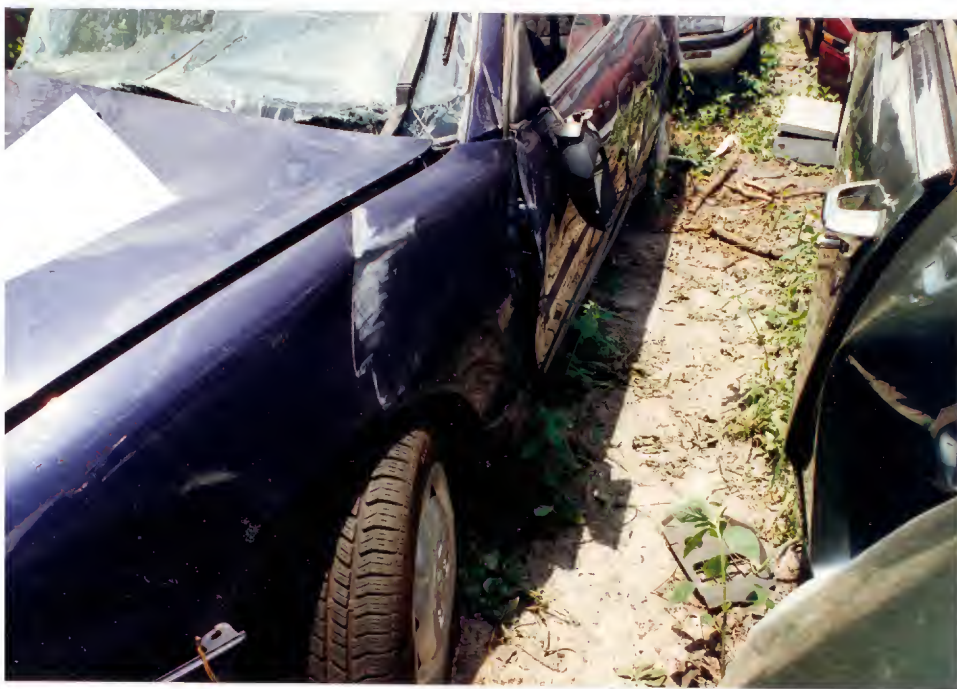
sign posts on a lateral travel path which resulted in a 9 o'clock impact force. The vehicle's impact sequence with the two sign posts resulted in four distinct impact patterns to the left side of the vehicle. This resulted from the vehicle's angular approach to the sign posts and the initial impact and penetration through the posts as the wooded posts fractured at multiple points. These patterns consisted of gray paint transfers with underlying superficial damage to the sheetmetal and glazing areas. The first point of contact was located on the left front fender and extended 1.3-22.2 cm (0.5-8.75") rearward of the left front axle position. The gray paint transfer extended vertically across the left front wheel cover and onto the fender directly over the tire. Due to the initiation of the roll and the fracturing of the wooden post, the transfer extended onto the top horizontal surface of the fender, ending 1.3 cm (0.5") onto the hood. Maximum crush was 1.9 cm (0.75") and was located at the upper surface of the fender 6.4 cm (2.5") rearward of the referenced axle. Photograph No. 15 documents this impact point.

The second contact point from the sign post was located on the left A-pillar 41.3-58.4 cm (16.25-23.0") rearward of the left front axle. The gray paint transfer began at the trailing edge of the fender 27.9 cm (11.0") above the ground and extended 17.8 cm (7.0") vertically to a stop point and continued 54.6-94.0 cm (21.5-37.0") above the ground onto the upper A-pillar. The transfer extended across the juncture of the fender and left front door. Maximum crush was 1.3 cm (0.5") located at the mid point of the trailing edge of the left front fender. Photograph No. 15 documents the damage. It should be noted that the depth of crush appears to be understated. This is due to lateral shifting of the frontal structure from an additional impact sequences that involved a right side tree impact and the subsequent rollover.

15. Sign post impact damage on left front fender and A-pillar.

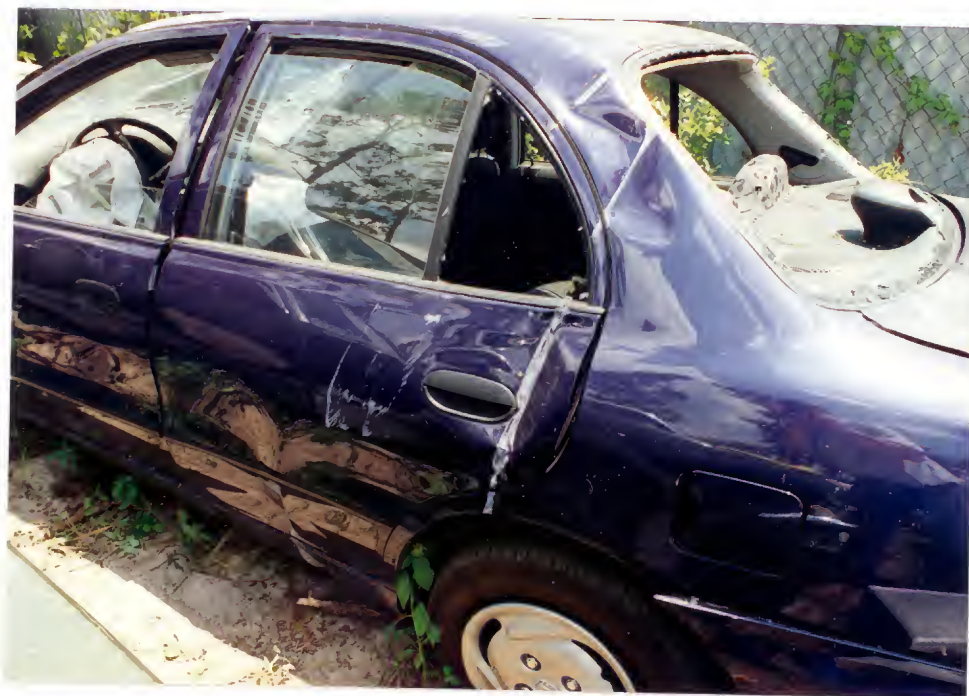
The second sign post damage pattern was located on the left rear door and C-pillar area. The initial contact damage was a narrow gray paint transfer which began 228.6-241.9 cm (90.0-95.25") rearward of the left front axle and extended vertically across the left rear wheel cover, onto the left rear quarter panel and door panel at the rear edge of the door handle, across the left rear quarter window and door window frame, and onto the upper C-pillar. The sheetmetal contact resulted in 3.8 cm (1.5") of crush located at the rear edge of the door handle and 2.0 cm (0.8") of crush at the upper C-pillar. The fixed quarter window glazing was shattered by the post contact. This damage pattern is documented in Photograph Nos. 16 and 17.

(12.75") to the beltline of the Hyundai. At this level, the transfer was located 193.7-215.3 cm (76.25-84.75") rearward of the front axle position and resulted in superficial sheetmetal damage. The post contact extended across the quarter window and onto the C-pillar and roof, resulting in 1.0 cm (0.4") of crush at the C-pillar area. This contact damage pattern is documented in Photograph Nos. 16 and 17.

16. Sign post impact damage on left rear door and C-pillar.

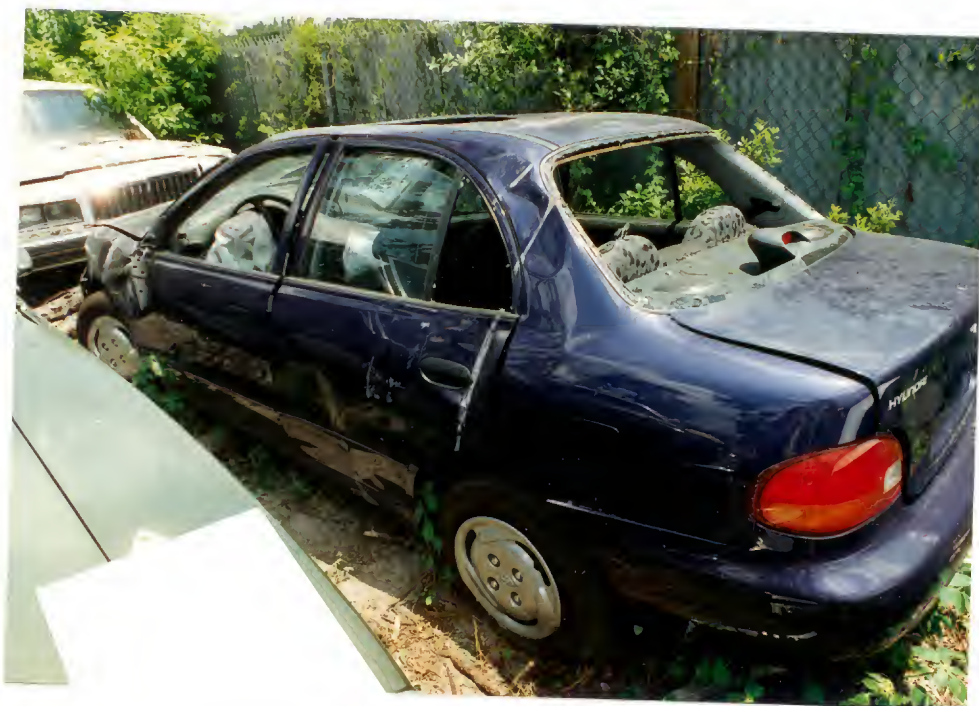
17. Overall left side view of the Hyundai.

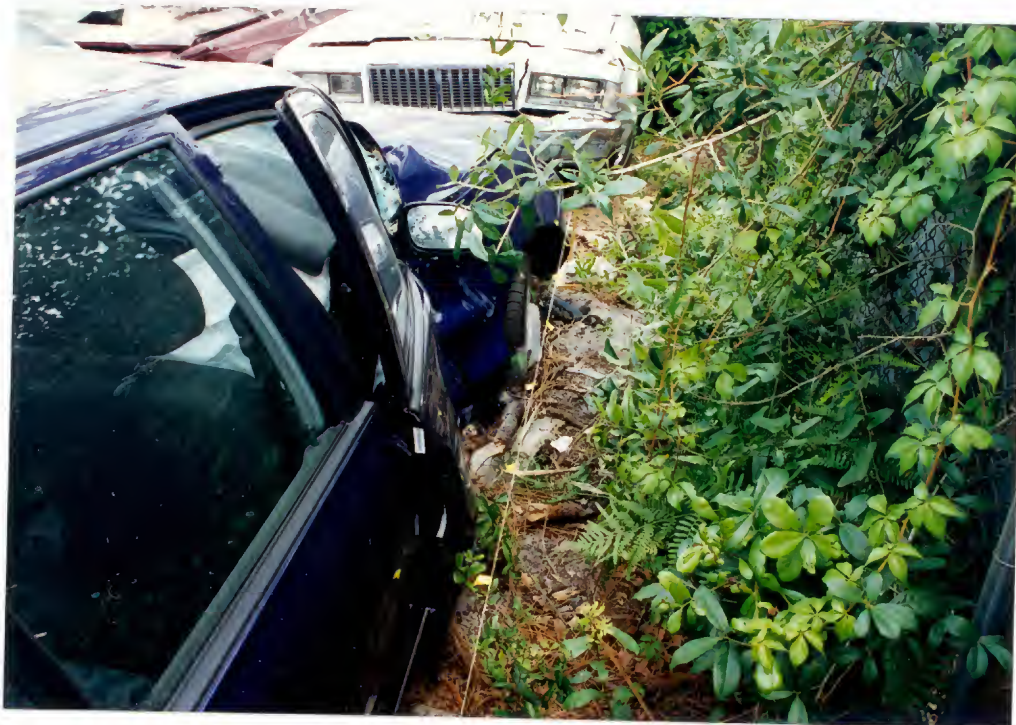
The Hyundai slid on its roof into a 22.9 cm (9.0") diameter tree (Event No. 6). The non-horizontal impact involved the right A-pillar area of the vehicle. The direct contact damage from the tree impact began 173.0 cm (68.1") forward of the right rear axle and extended 24.1 cm (9.5") forward. The lateral extent of maximum crush was 28.3 cm (11.1") that was located on the right door 7.6 cm (3.0") rearward of the right A-pillar. The combined induced and direct contact damage began at the trailing edge of the left front door and extended 152.4 cm (60.0") forward to the mid aspect of the right front fender. The crush profile at mid door level was as follows: C1 = 0 cm, C2 = 3.8 cm (1.5"), C3 = 19.7 cm (7.75"), C4 = 36.8 cm (14.5"), C5 = 2.9 cm (1.1"), and C6 = 0 cm.

19. Right side damage that resulted from the tree impact.

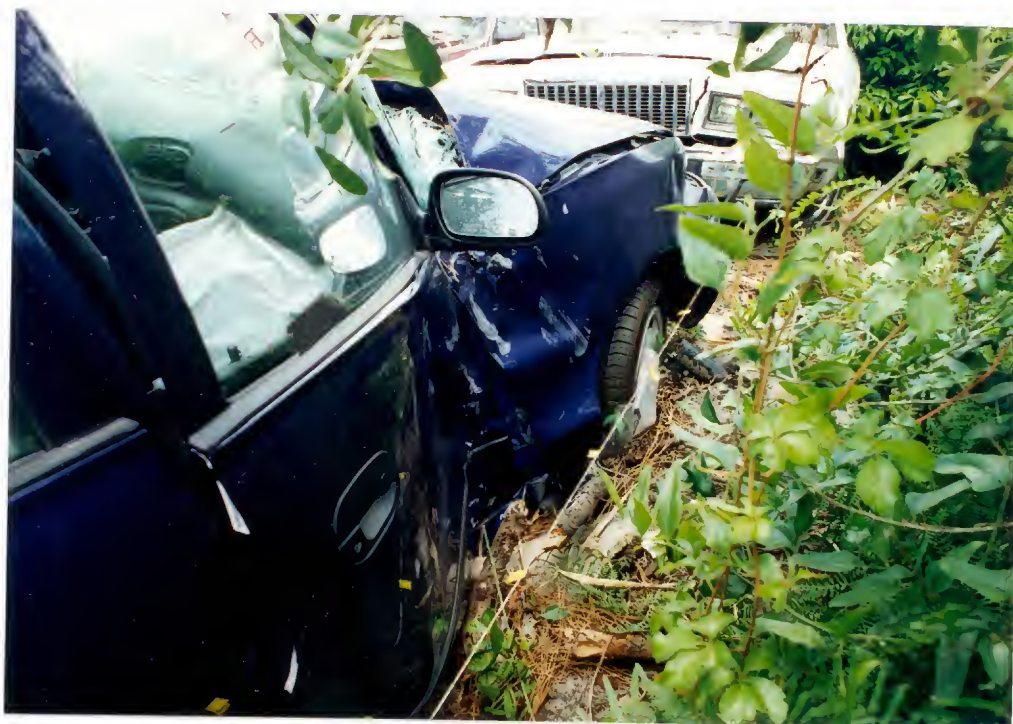
20. Tree impact damage at the right A-pillar area.

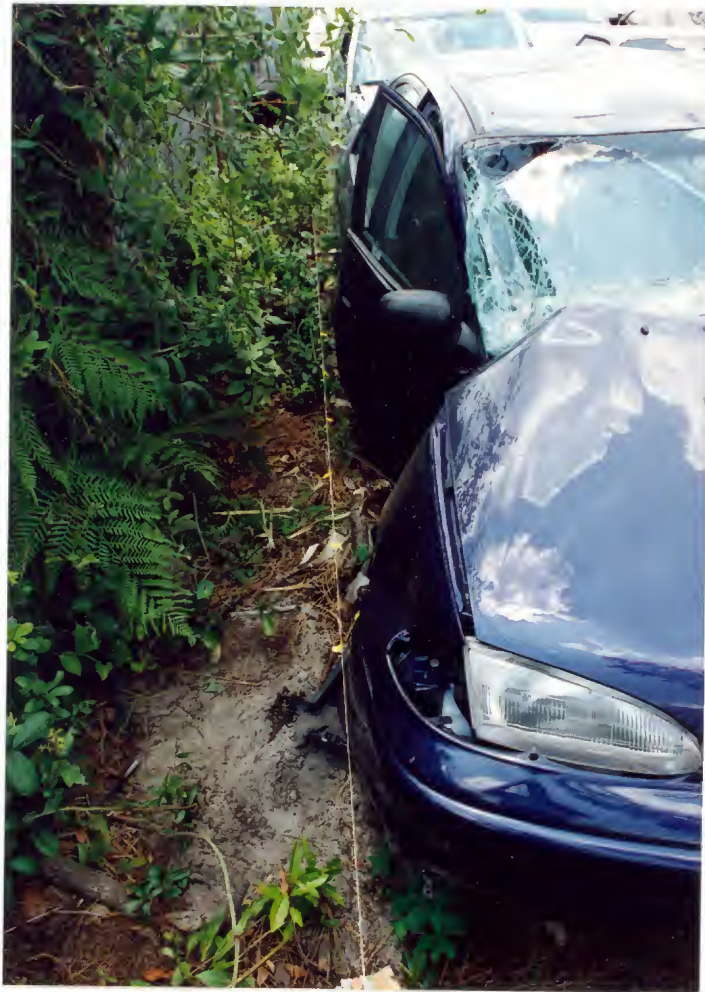
22. Longitudinal view documenting the extent of lateral crush at the right A-pillar.

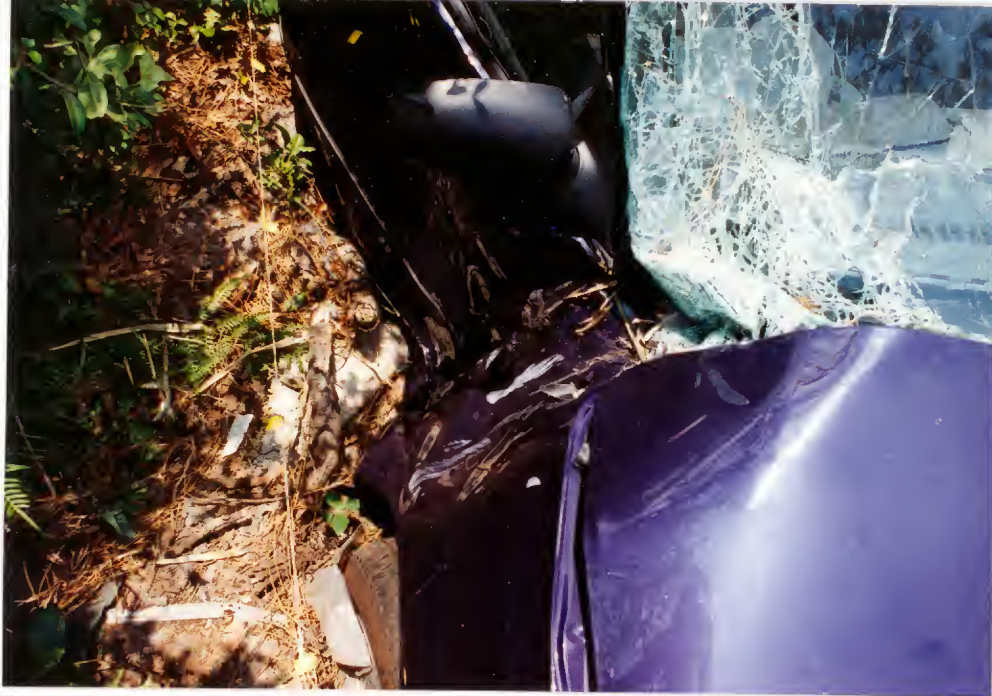
23. Close-up view of the tree impact damage.

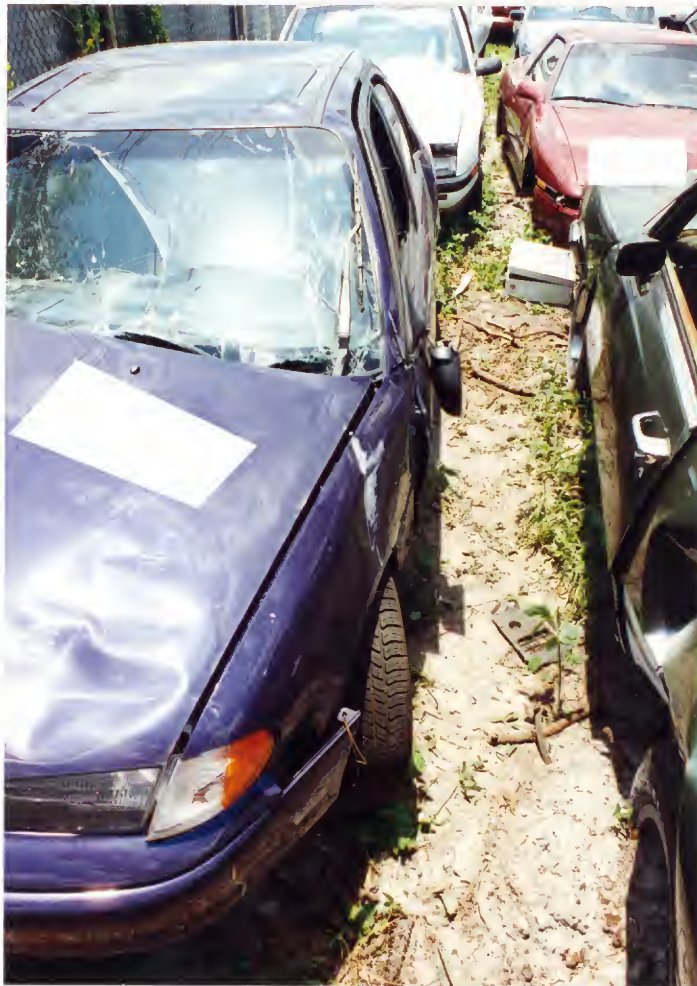
The interior of the Hyundai Accent sustained moderate damage that was associated with exterior deformation, intrusion of interior components, and deployment of the supplemental air bag system. The intrusion resulted from lateral displacement of the right A-pillar and door from the non-horizontal impact with the tree (Event No. 6). Maximum intrusion involved 14.0 cm (5.5") of lateral displacement of the right mid A-pillar which compressed the right instrument and rotated the passenger side air bag module assembly (refer to Photograph No. 52). The glove box door subsequently opened as a result of A-pillar displacement and panel compression.

24. Lateral displacement of the frontal structure that resulted from the right side tree impact.

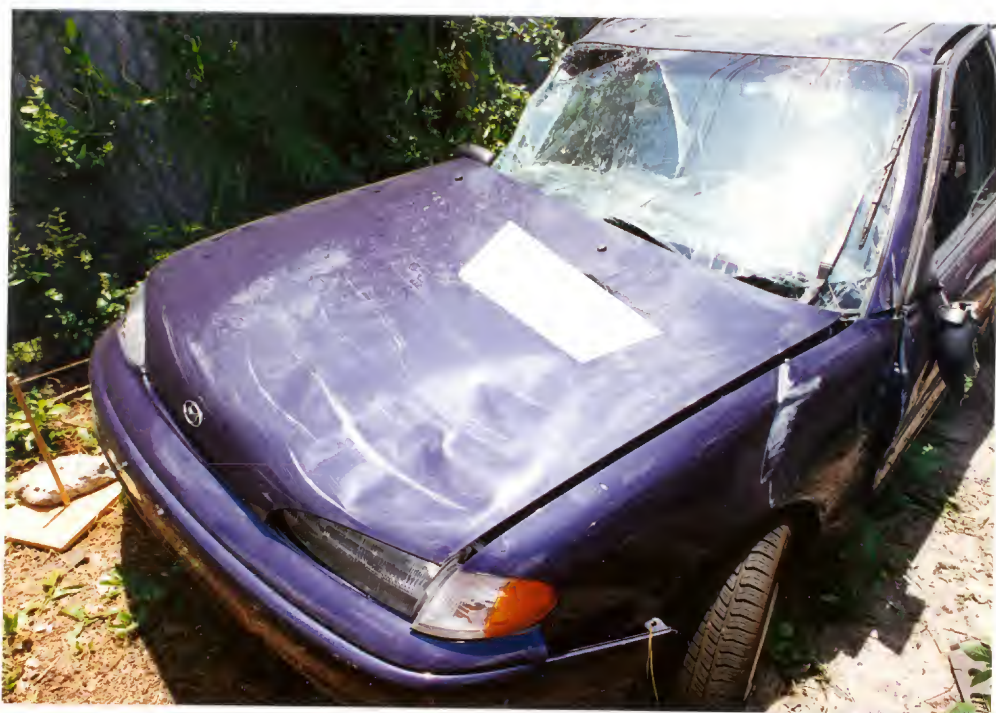
The Hyundai subsequently initiated a lateral rollover sequence to its left which resulted in minimal left side contact damage before rolling onto its roof (Event No. 5). Vertically oriented abrasions were noted to the left front fender which extended 71.1 cm (28.0") rearward of the leading edge. The left A-pillar mounted rear view mirror was fractured from its mount as a result of the rollover, however, there was no contact damage to the left side doors or rear quarter panel. As the Hyundai rolled onto its roof, superficial dents and laterally oriented abrasions were present on the hood. This contact damage began at the left hood edge, 63.5 cm (25.0") left of center and extended to a point 33.0 cm (13.0") right of center. The superficial damage extended 58.4 cm (23.0") rearward from the hood face. The abrasions from the rollover sequence extended 96.6 cm (38.0") rearward of the left A-pillar/windshield header juncture onto the left roof side rail. As the Hyundai overturned onto its roof, superficial abrasions extended across the full length (101.6 cm) and width (134.6 cm) of the roof panel. Maximum crush was 3.8 cm (1.5") located at the mid rear seat area 88.9 cm (35.0") rearward of the windshield header. The tempered glass sunroof remained closed and intact during the rollover sequence. There was no contact damage on the trunk lid of the vehicle.

25. Rollover contact damage across the hood of the Hyundai.

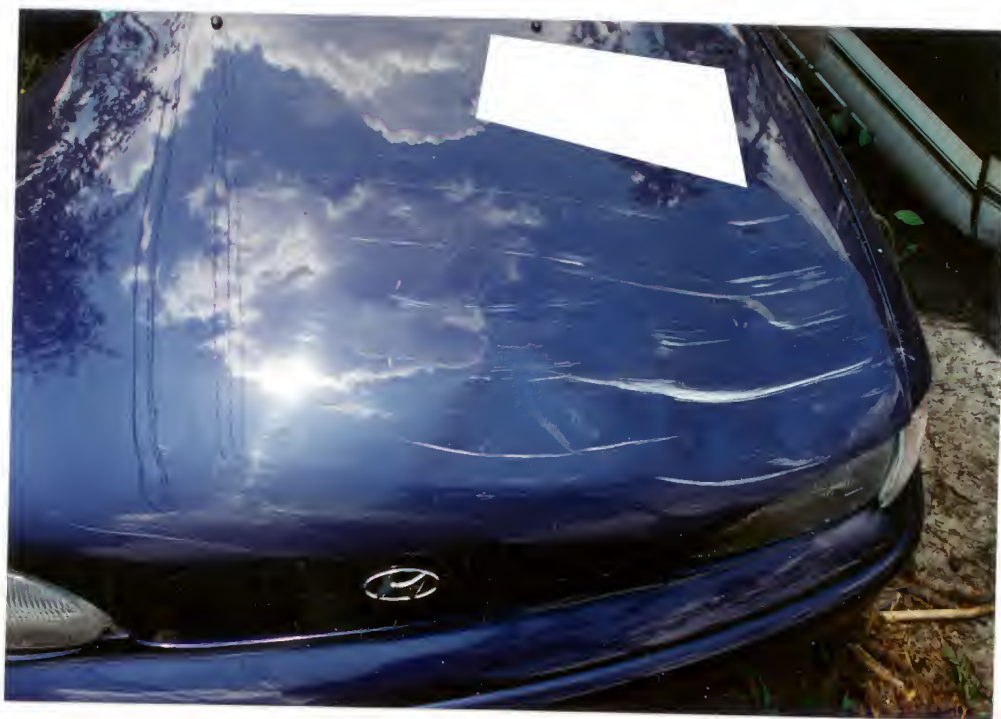
26. Close-up view of the laterally oriented abrasions.

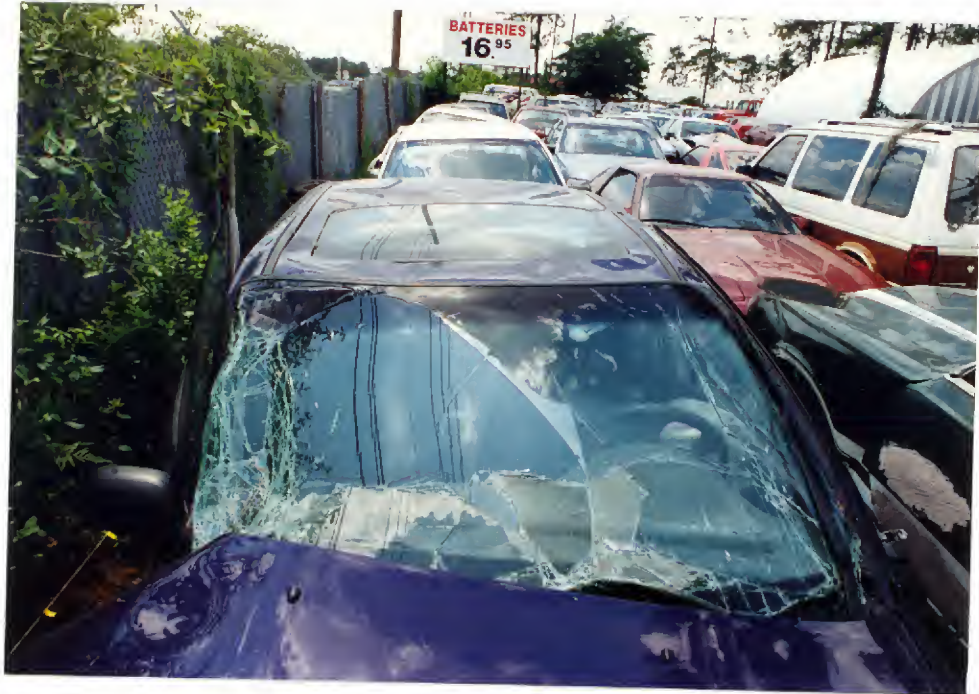
27. Minimal roof crush from the rollover event.

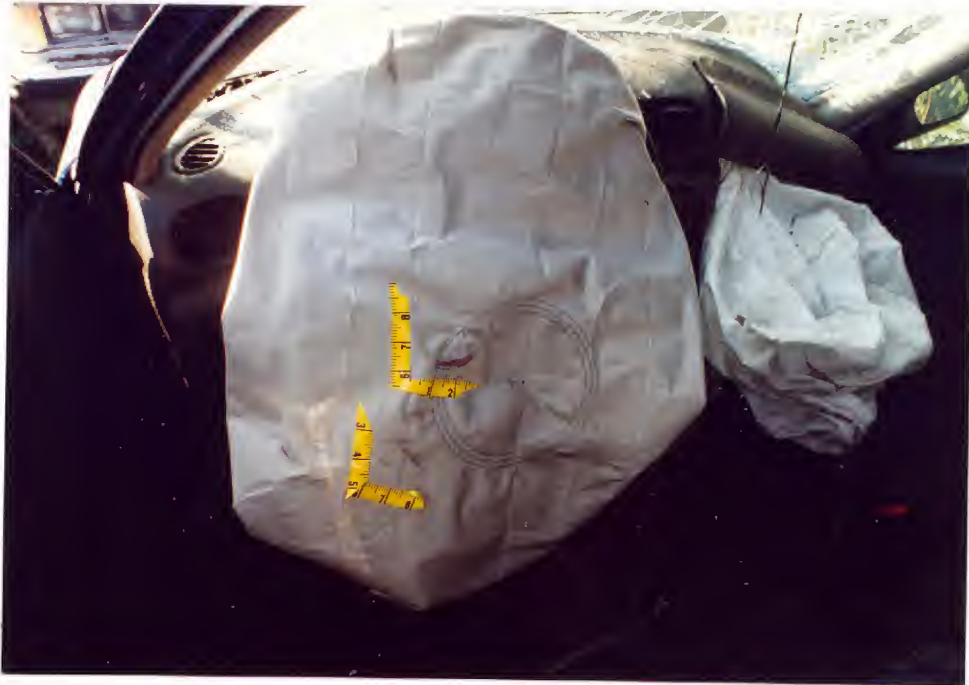
The supplemental driver and passenger side air bag system deployed as designed from the respective module assemblies. The driver's face contacted the deployed driver's side bag as evidenced by lipstick transfers on the face of the bag. The passenger side air bag fabric expanded against the rearward facing child restraint. As a result of expansion against the infant restraint, fabric transfers were present on the bag fabric from the lining of the infant restraint. There was no damage to the air bag fabrics.

31. Driver lipstick transfers on the deployed driver's side air bag.

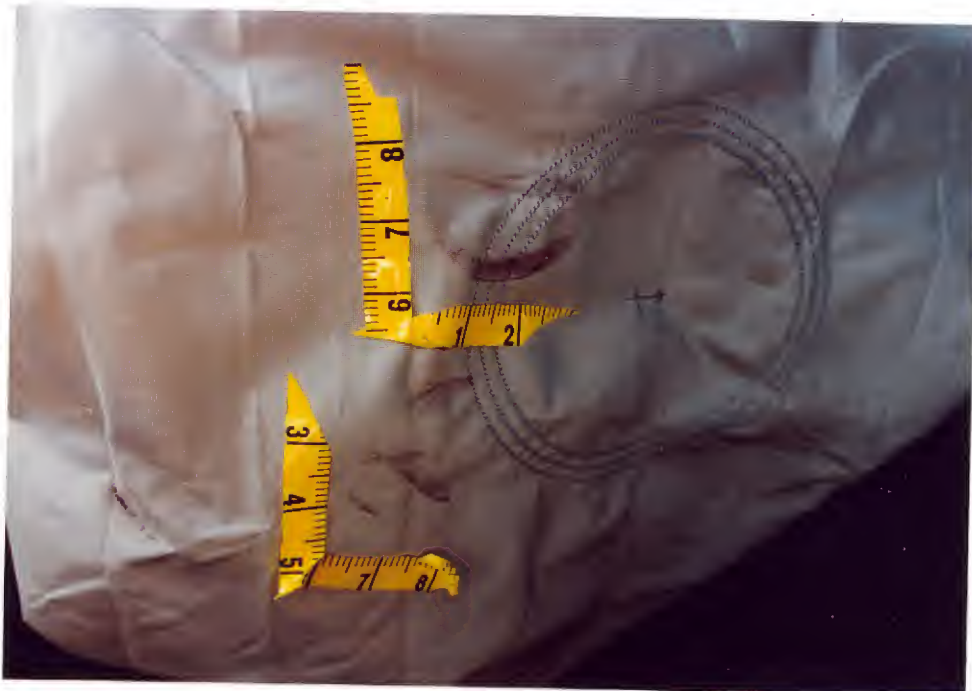
There was no damage (i.e., tears, abrasions, burns) to the deployed driver's side air bag. Driver facial contact with the deploying air bag resulted in lipstick transfers to the lower center area of the bag. The transfers were vertically oriented on the air bag (refer to Photograph Nos. 31 and 32) which indicated the steering wheel was rotated approximately 90 degrees in a clockwise direction as the SRS deployed. Irregular purple shade transfers were located 1.3-6.4 cm (0.5-2.5") right of the vertical centerline of the bag and 7.6-12.7 cm (3.0-5.0") below the horizontal centerline. These lipstick transfers consisted of four distinct marks that were located directly outboard of the tether reinforcement stitching. The most pronounced lipstick transfer was located 3.8-9.5 cm (1.5-3.75") below the horizontal centerline and 1.9-5.7 cm (0.75-2.25") left of center. As documented on Photograph No. 32, the upper and lower lipstick transfers were separated by 2.3 cm (0.9").

32. Close-up views of the lipstick transfers with the steering wheel rotated 90 degrees CW.

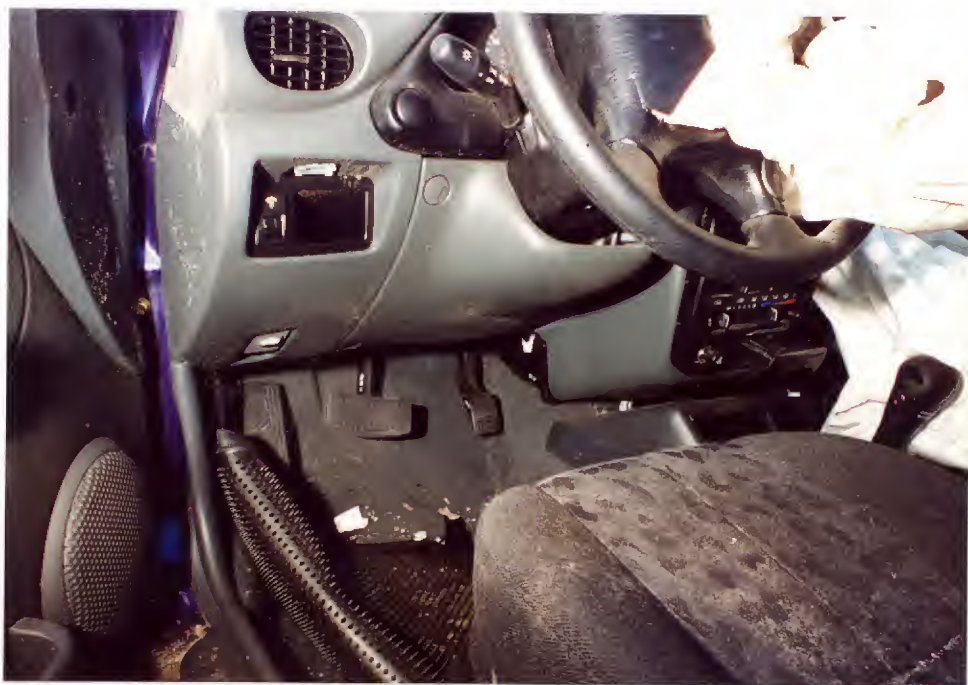
38. Driver's side knee bolster (no contact evidence) and deformed brake pedal.

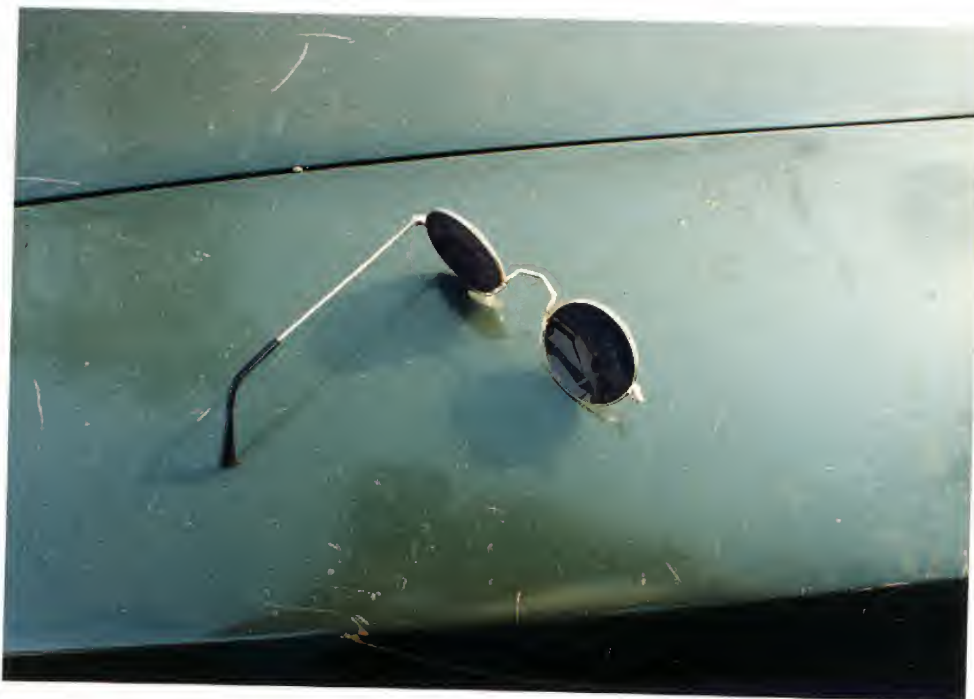
45. Deformed sunglasses worn by the driver of the Hyundai.

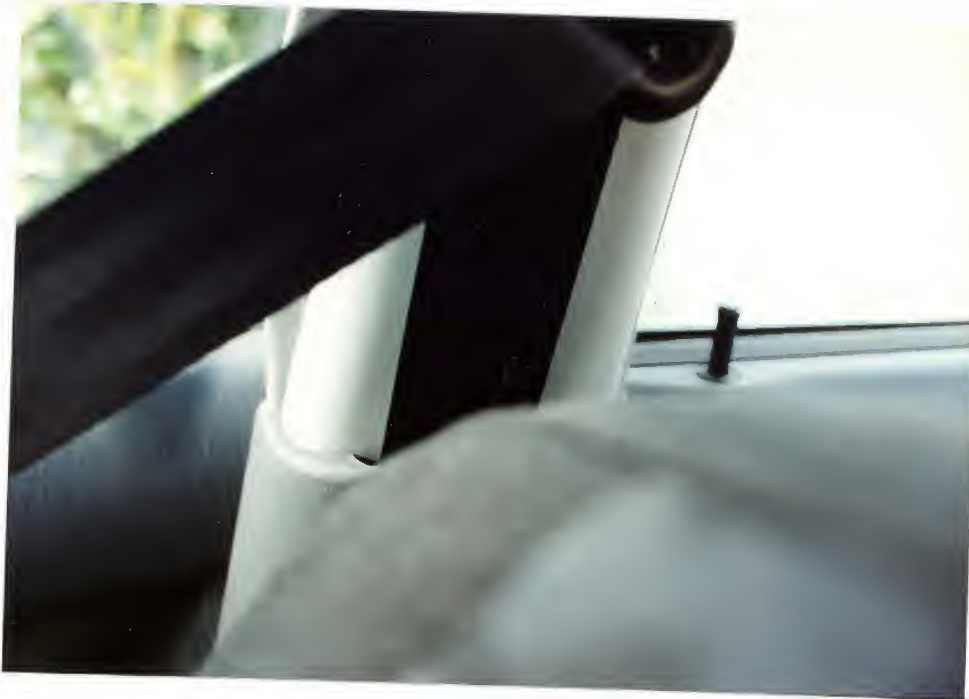
67. Circular transfers on the right front shoulder belt webbing.

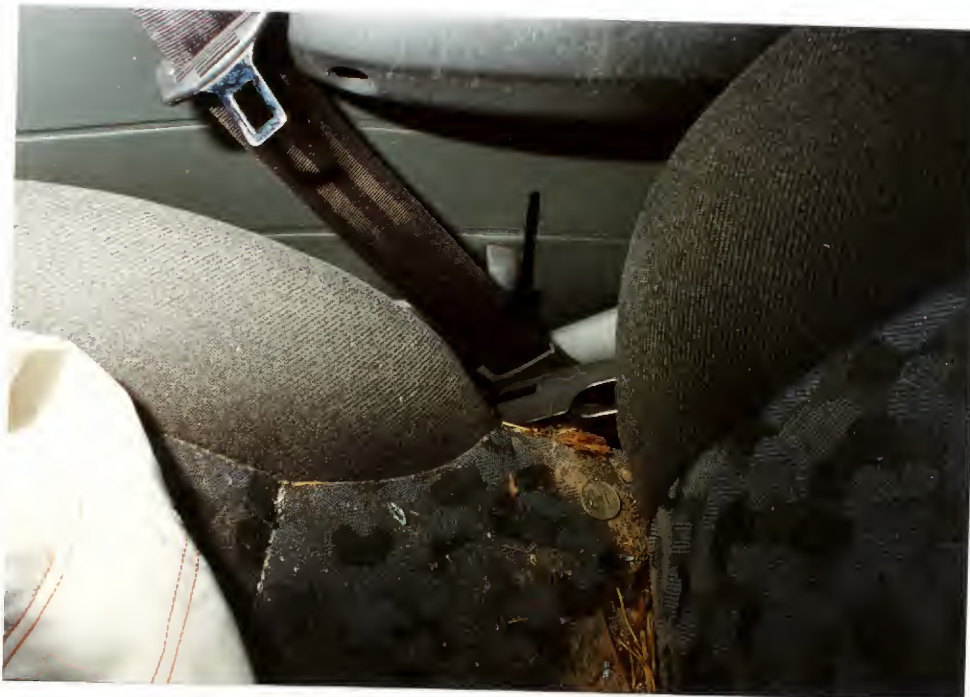
The right front belt webbing was scuffed on the inboard aspect at its contact point with the plastic cover for the seat back/seat cushion juncture. A vertically oriented scuff/abrasion was noted to the inboard aspect of the webbing 4.4-6.4 cm (1.75-2.5") below the latchplate stop button. In addition, two semi-circular marks located on 3.5 cm (1.4") centers, were present on the inboard aspect of the webbing 81.3 cm (32.0") above the stop button. The overall width of the webbing was 4.8 cm (1.875"). Routine wear marks were present on both sides of the right front latchplate.

68. Abrasion on belt webbing from plastic extrusion located at the outboard aspect of the right front seat cushion/seat back juncture.

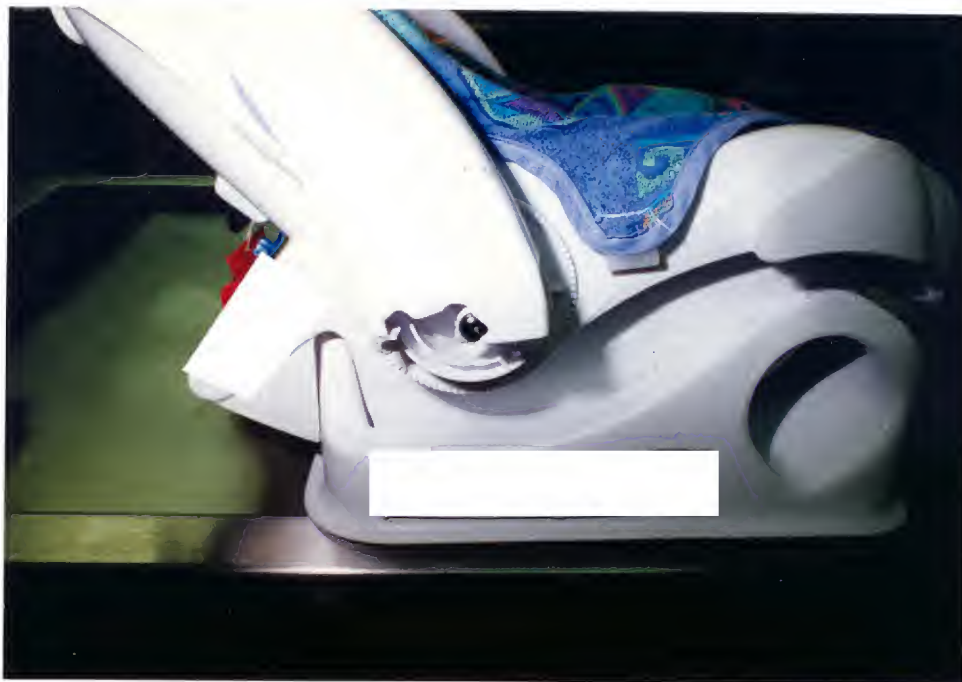
pivot points and fractured the left side pivot, partially separating the handle from the shell (refer to Photograph No. 73). Bag expansion against the shell of the restraint produced a single fracture line that extended across the slots for the shoulder belt harnesses. The fracture line radiated from the inboard aspect of both harness slots and extended 2.9 cm (1.9") inboard to a cutout area at the center of the shell (refer to Photograph No. 76).

73. Fractured right side pivot of the infant restraint.

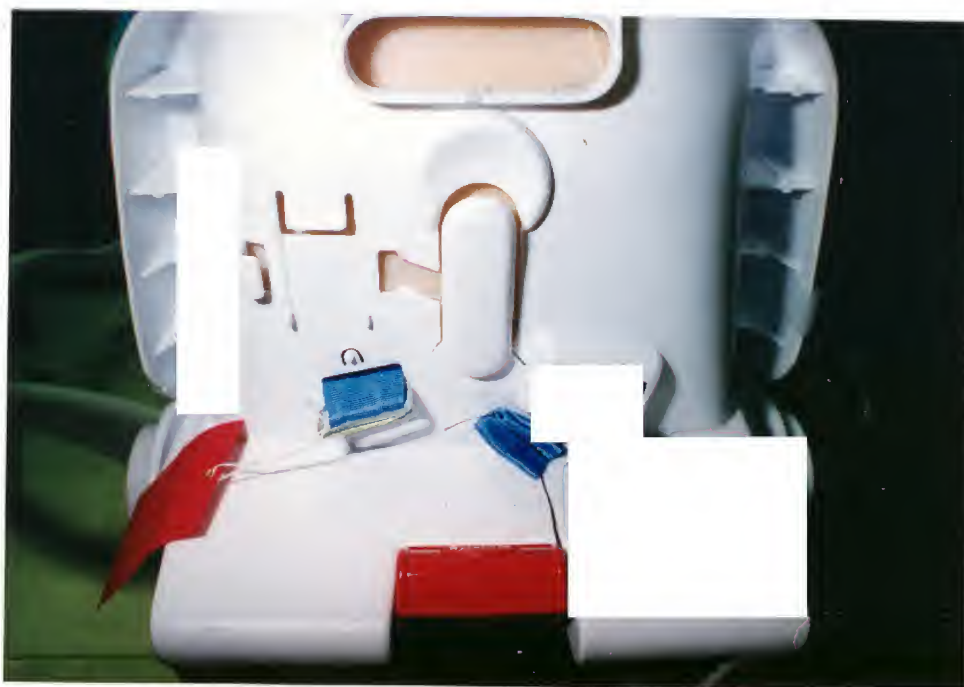
The deploying passenger side air bag contacted the leading edge of the rear-facing infant restraint. The contact resulted in two 2.9 cm (1.1") fracture lines in the plastic shell of the restraint at the mid point, located between the integral harness slots and a plastic belt webbing tab. In addition to the fractures, the carrying handle was heavily abraded across the full width of the restraint from air bag contact.

76. Fracture points of the rear (leading) side of the plastic shell of the restraint.

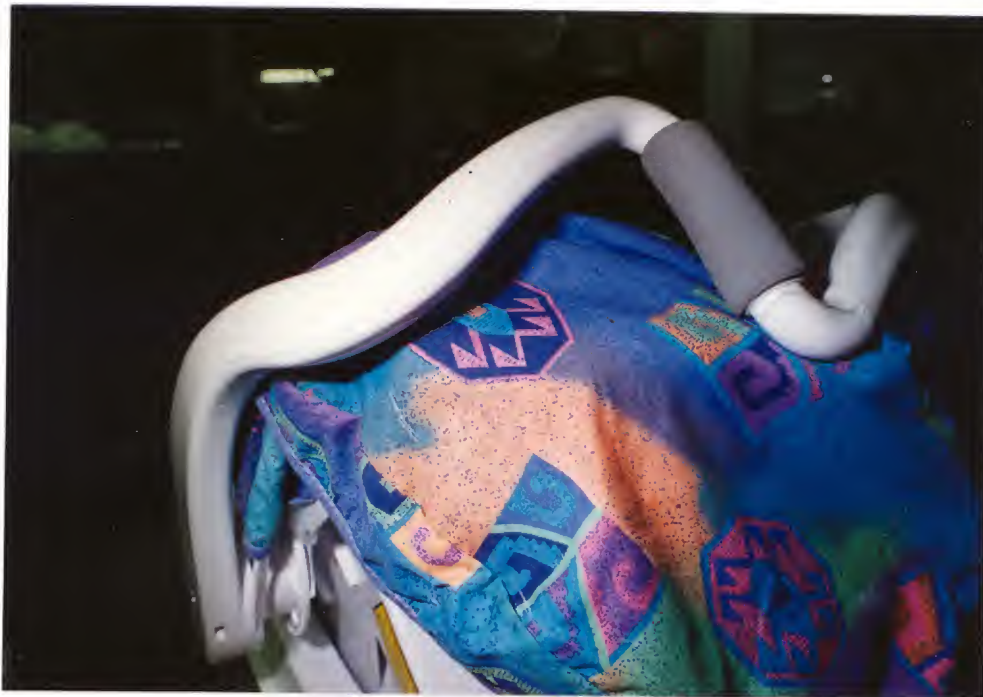
79. Air bag induced abrasions to the plastic carrying handle.

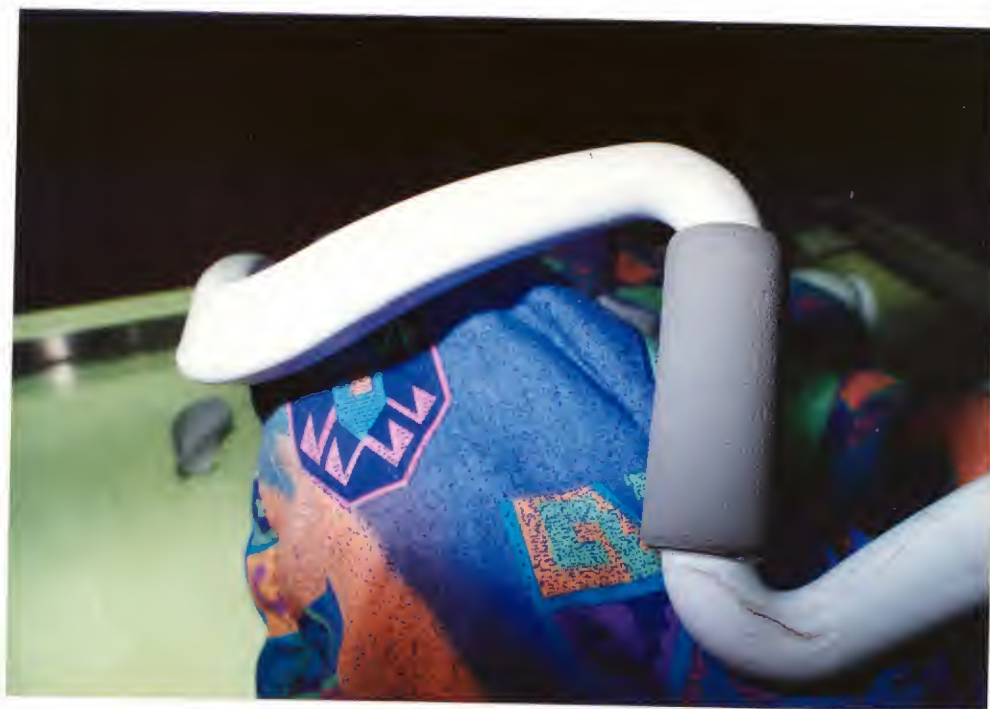
80. Additional view of the abraded carrying handle.

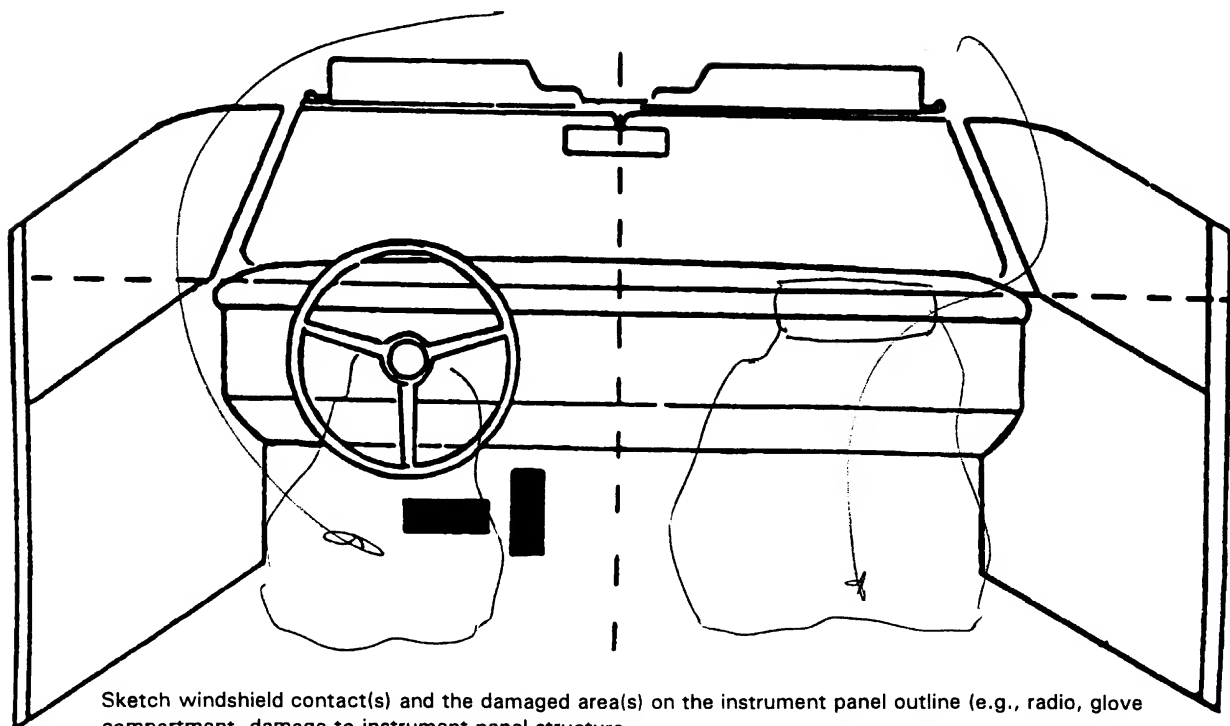
CHILD RESTRAINT
TRANSFERS ON
PASSENGER SIDE BAG

There was no damage to the passenger side air bag and/or the module cover assembly, however, fabric transfers from the rearward facing child restraint were noted to the upper aspect of the bag. A vertically oriented red fabric transfer was located 2.5-12.7 cm (1.0-5.0") below the upper seam (refer to Photograph No. 56). A faint blue fabric transfer was located 14.0-20.3 cm (5.5-8.0") left of the bag's centerline and 5.1-21.6 cm (2.0-8.5") below the referenced seam.

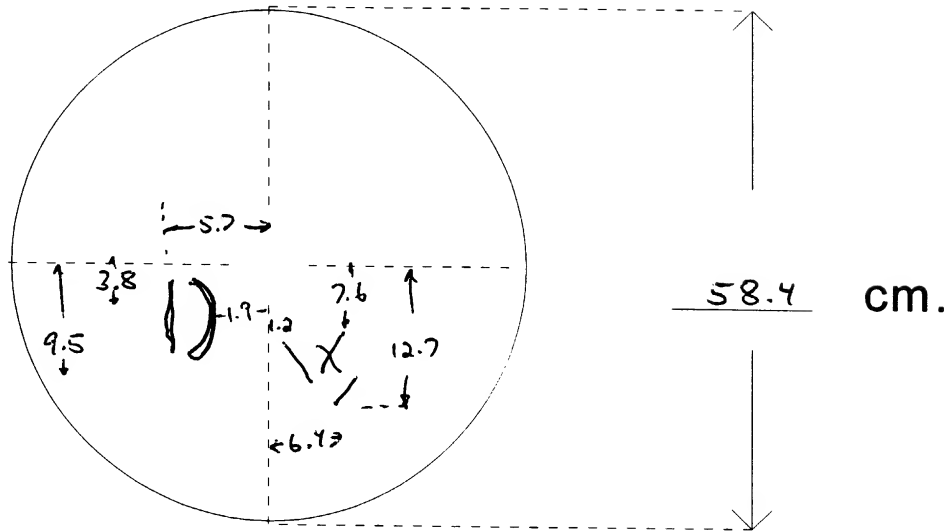
LIPSTICK
TRANSFERS
WHEEL ROTATED 90 CW
IN PICS.
